**Project Description & Goals:**

Name: High Performance Micro Office Village  
 Size: Historic house - 1800 sf.  
           Studio - 1200 sf.  
           3000 total square feet  
 Type: Professional Office  
 Occupancy: Business (Group B)  
 Date of Completion: September 2014

High Performance  
Micro Office Village

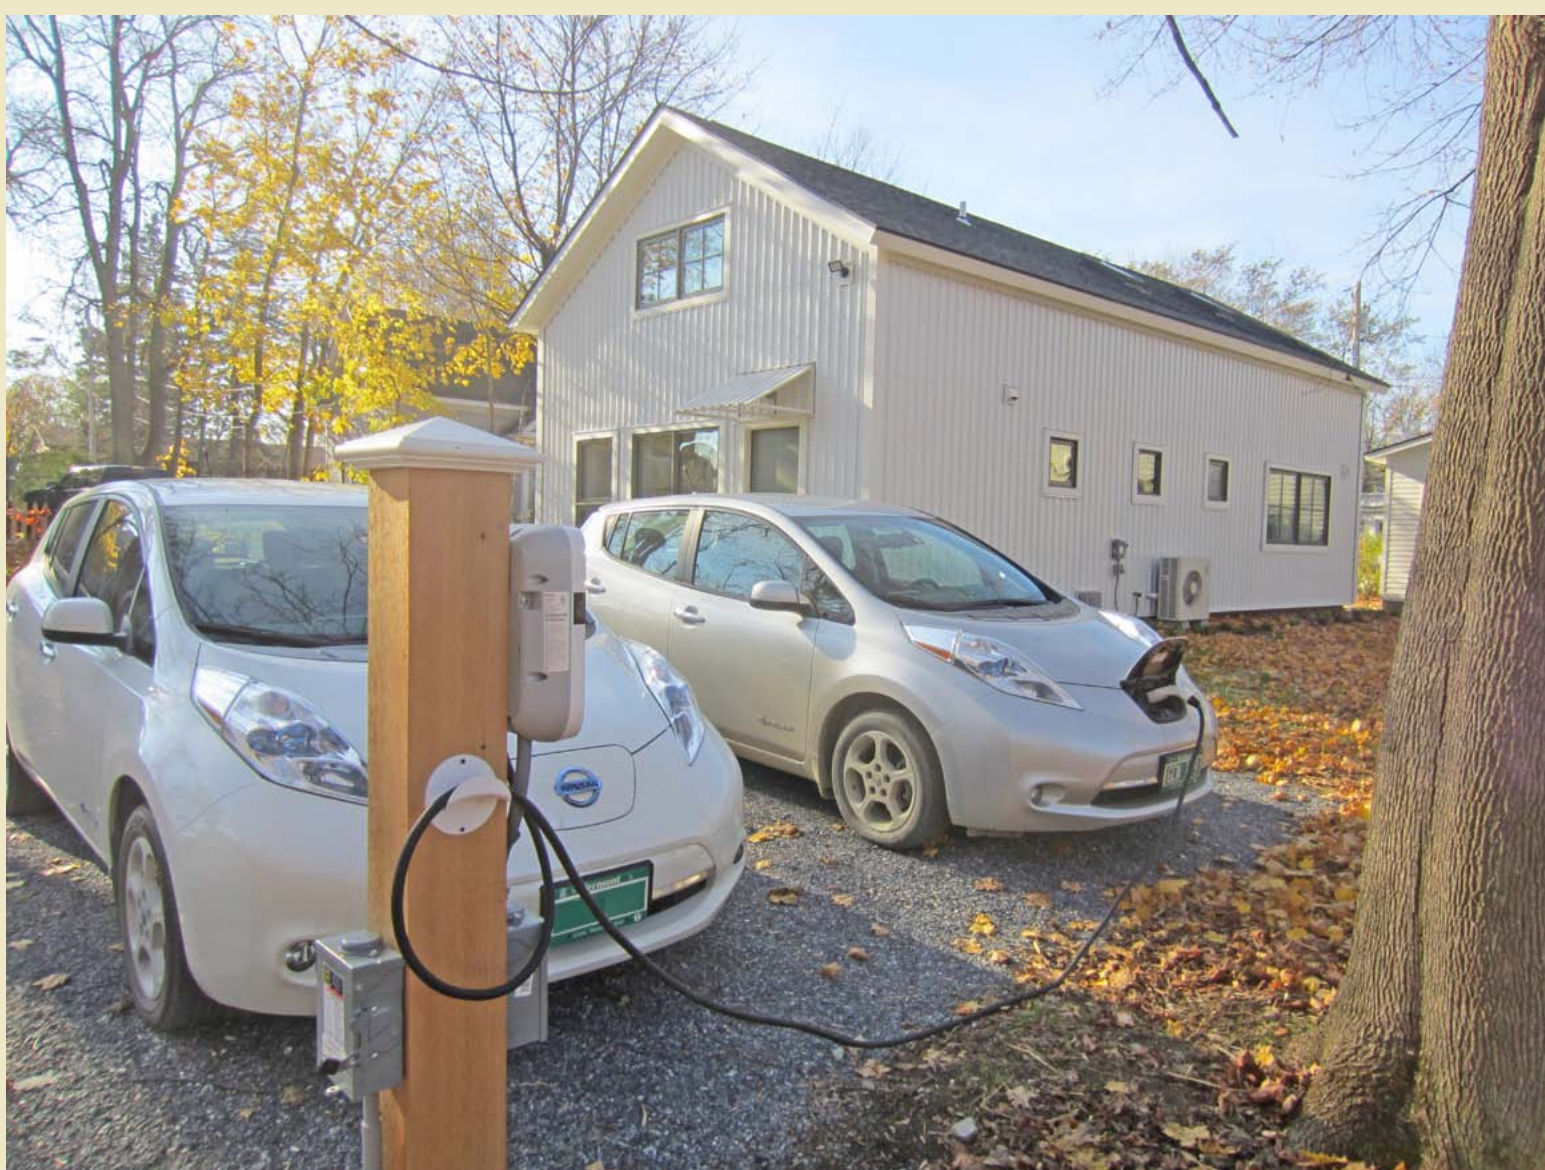
Electric vehicle charging

**EV charging station:** An electric vehicle charging station was installed in the parking area with wiring for another future station. **Renewable energy:** A wiring chase was installed from the main panel to just below the roof of the studio for a PV system, allowing this project to attain net zero energy use in the future. Energy Star appliances: **Energy Star rated** compact refrigerators were provided for kitchenettes.

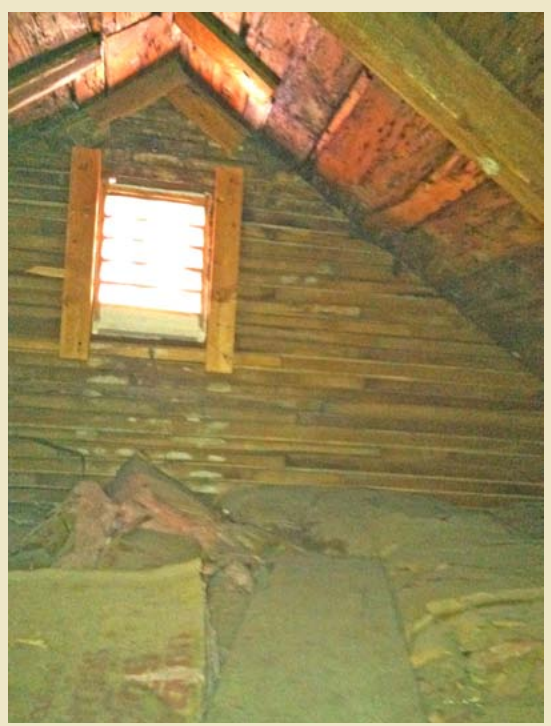
Roof / Attic: Before  
Minimal batt insulation in attic.

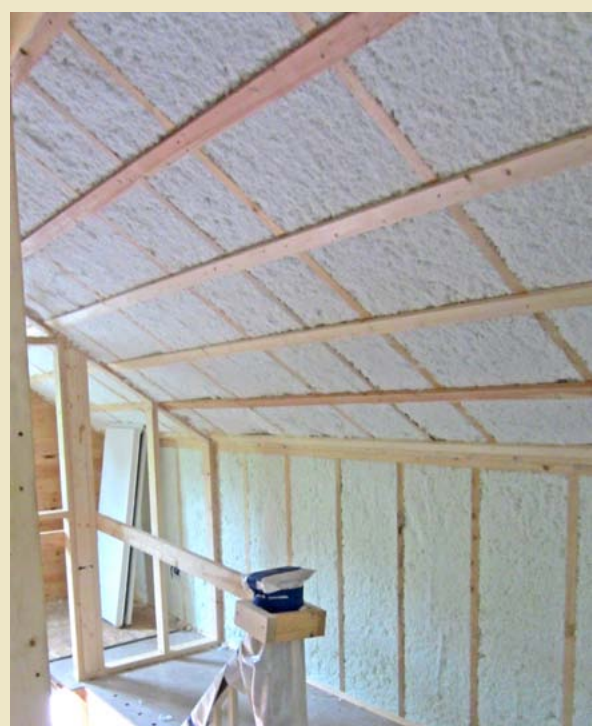
Roof / Attic: After  
4" of rigid insulation was added to the roof, as well as 7" of spray fiberglass, bringing the roof assembly up to R-54

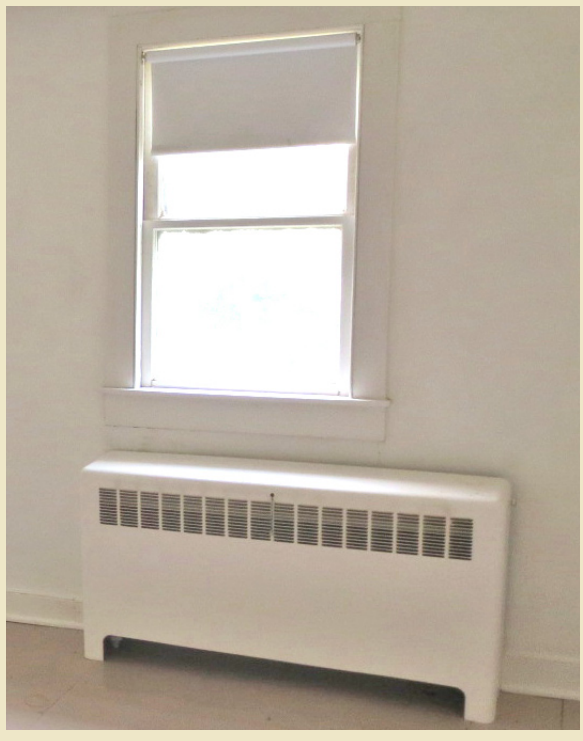
Mechanical: Before  
Radiators tied to oil boiler

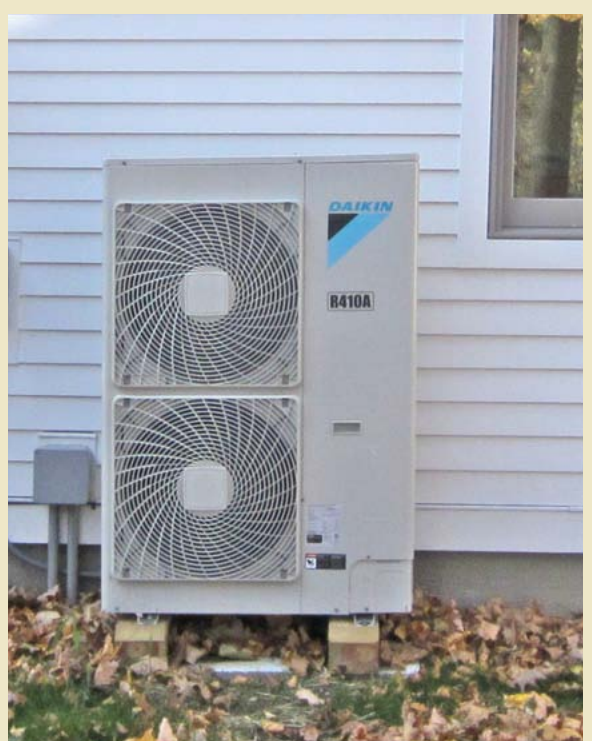
Mechanical: After  
Daikin ducted air source heat pump, with existing Budarus boiler gas fired backup.

**HVAC: Equipment & Controls:** Both buildings use heat pumps for heating and cooling. The Studio uses a mini-split which is a cold climate ASHP rated to -18 F with an effective COP of up to 4.1 (depending on outdoor temp.) In the historic house the small rooms warranted better distribution and it was more cost effective to go with a ducted ASHP. This unit is rated to 0 F and has a COP of 3.6 (depending on outdoor temp.) In this building we used the existing boiler and forced HW system as back up. **Ventilation:** Because of the size and scale of both buildings we used Lunos point source HRV’s to deliver fresh air to the spaces, this provided the best cost to benefit ratio. These are rated at 90% efficiency and were very easy to install into the existing building infrastructure. Low flush toilets and low flow faucets were also installed in the bathrooms

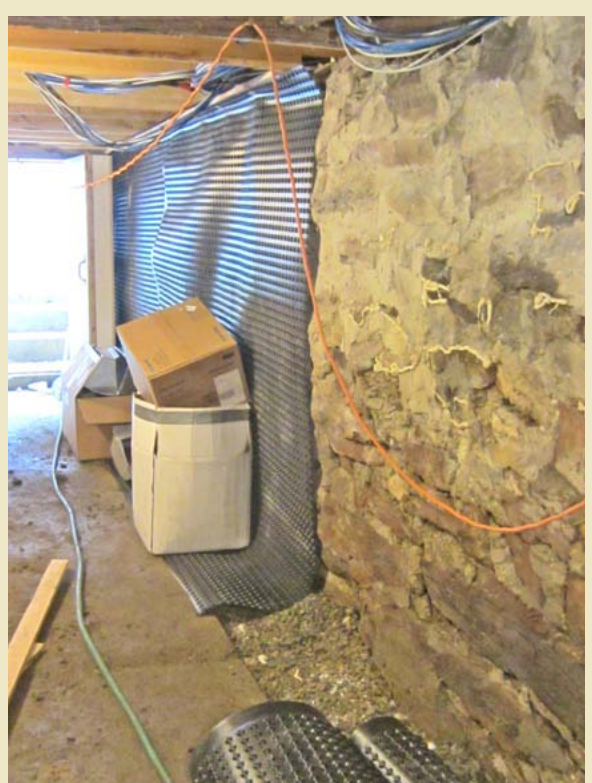
Foundation wall: After  
New drainage mat over the foundation wall connected to a perimeter drain trench and tied to a sump pump.

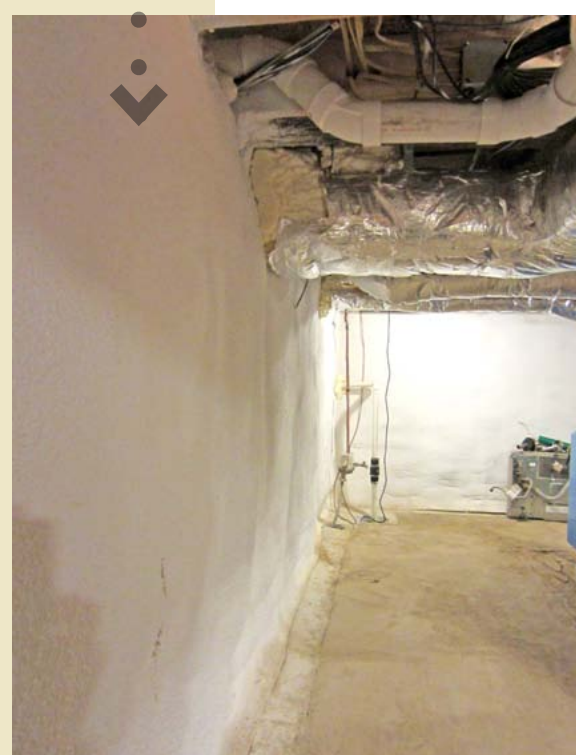
Foundation wall: After  
4" spray foam insulation with intumescent paint added over the drainage mat.

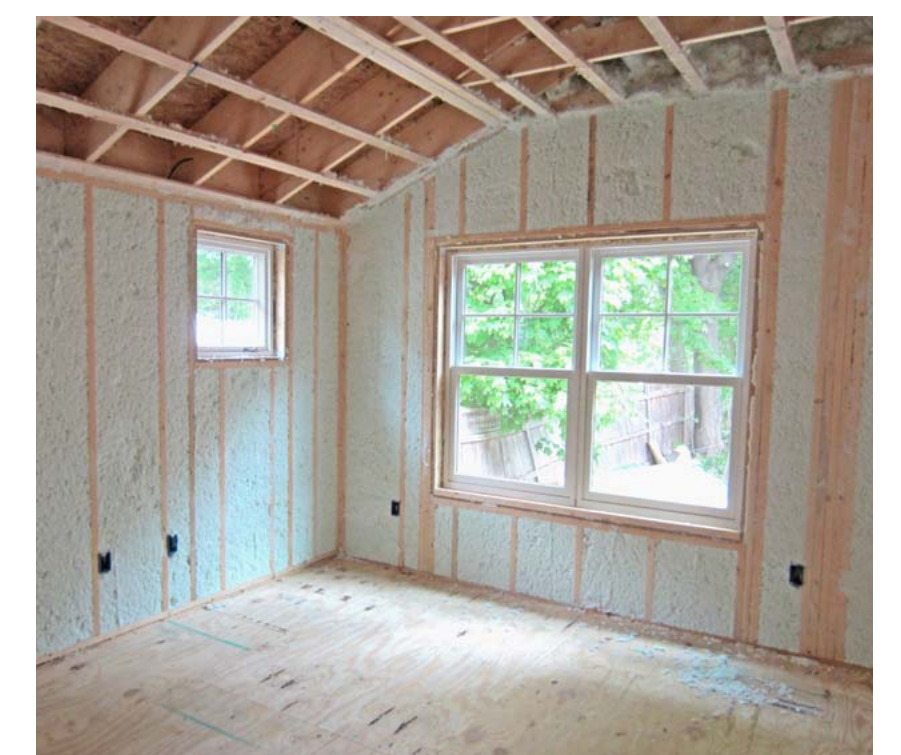
Spray fiberglass insulation at the new addition.

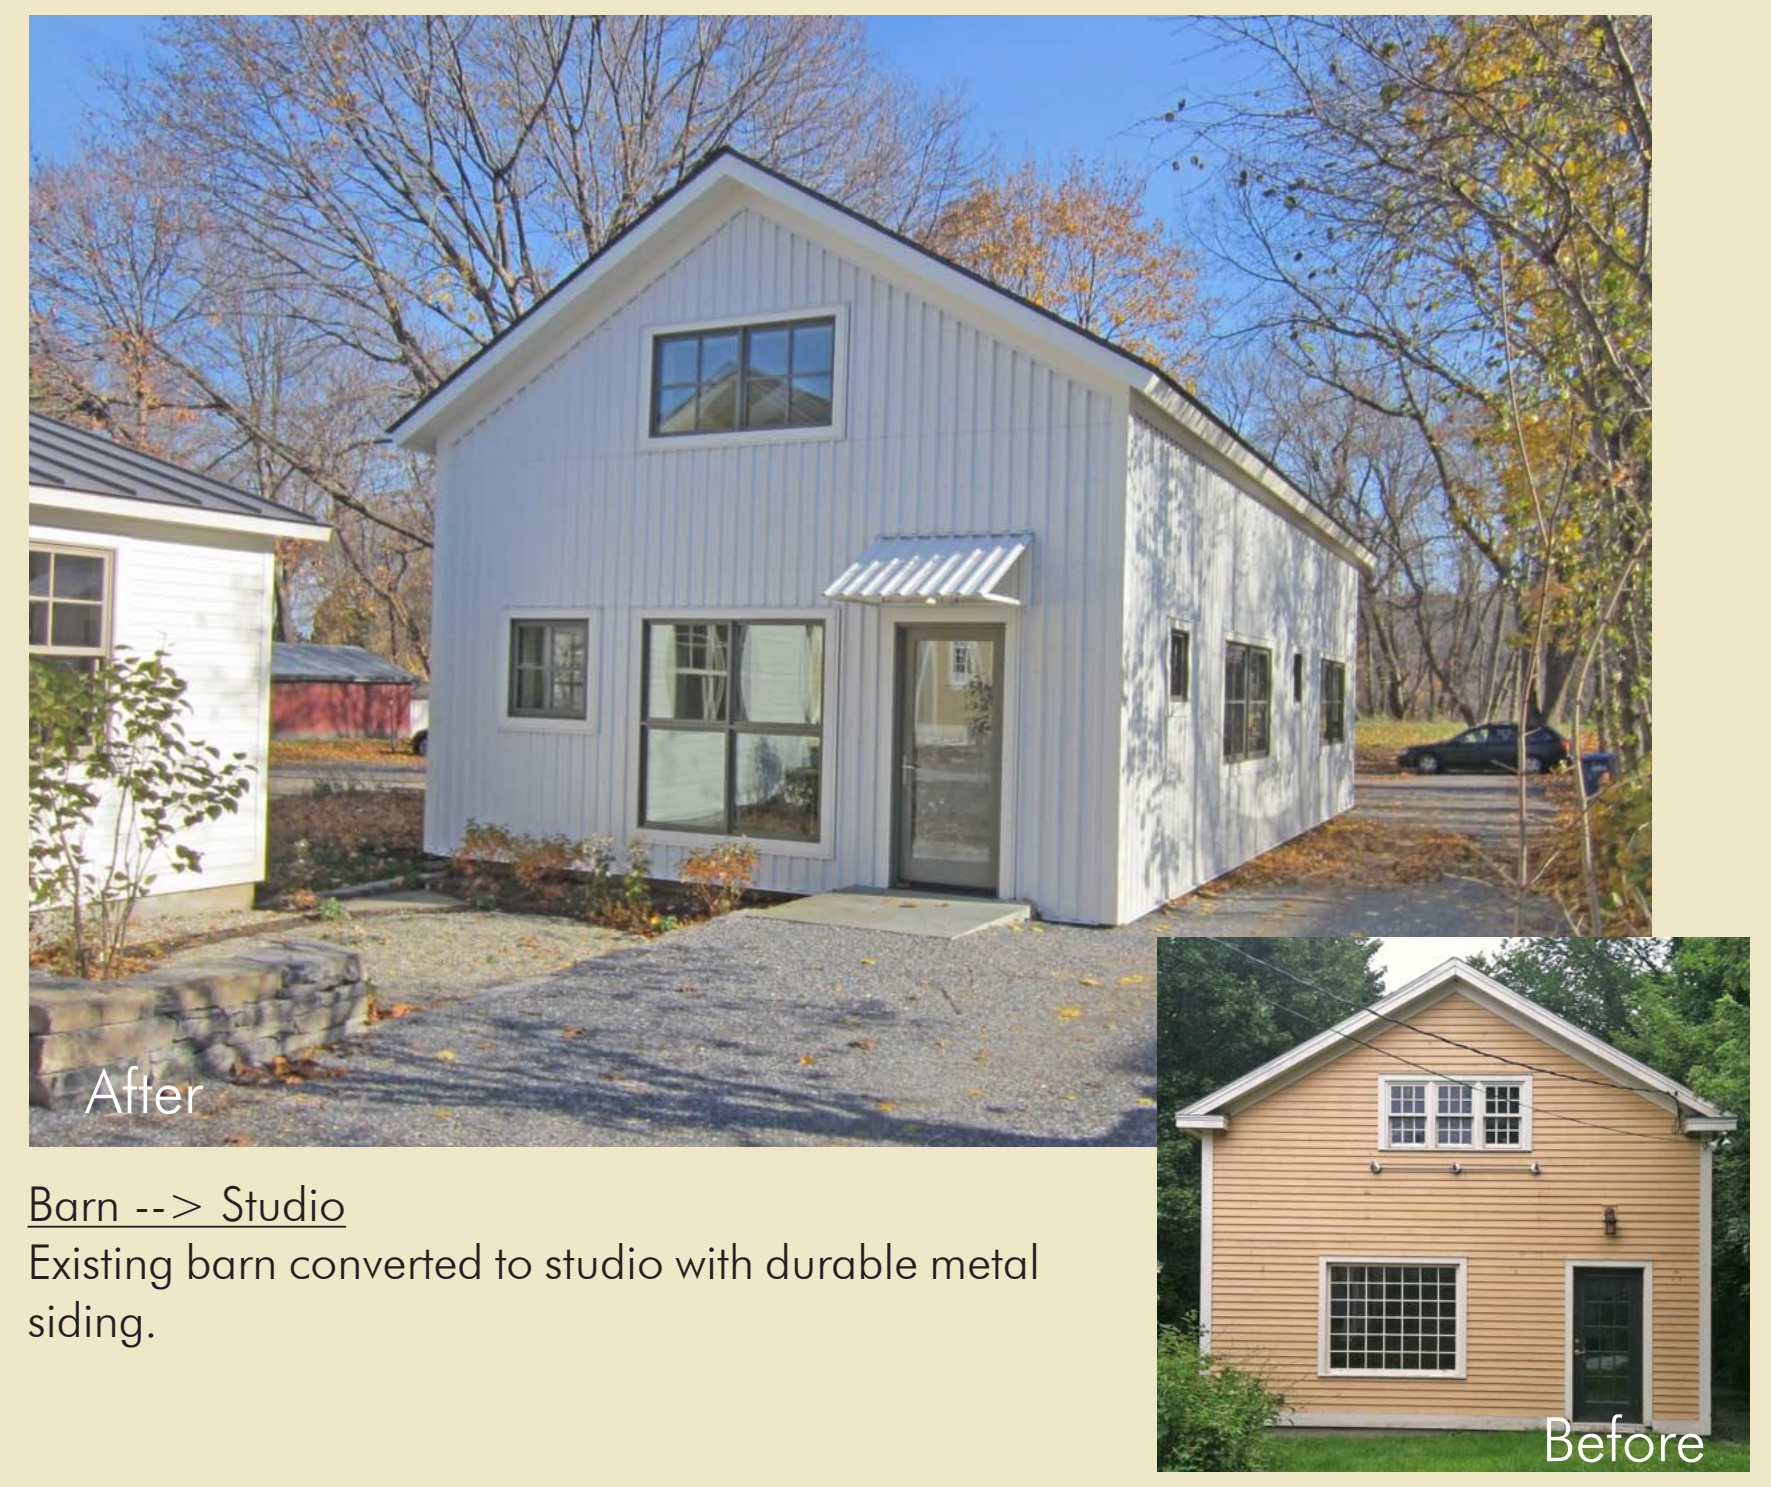
Section Key

- 1 Existing architectural shingle roofing and sheathing to remain
- 2 Existing 2x10 rafters to remain with new dense pack cellulose
- 3 2" polyisocyanurate insulation attached to underside of 2x10s
- 4 New GWB attached to strapping
- 5 New structural tie rod and angle
- 6 New 2x6 rafter extension, sistered to existing roof rafters. 4" rigid insulation runs in between, taped & sealed.
- 7 New wood fascia & soffit
- 8 Typical wall construction (exterior to interior): Metal siding, 5/8" Zip wall sheathing, over 4" thick foil faced polyisocyanurate insulation, over existing sheathing, over existing 2x6 stud wall with new spray fiberglass insulation, over new GWB
- 9 New cork flooring over existing plywood over 2x sleepers with 1 1/2" rigid insulation over existing concrete slab
